SCUBAPOXY 1725

Underwater-applied Coating & Adhesive

Case History

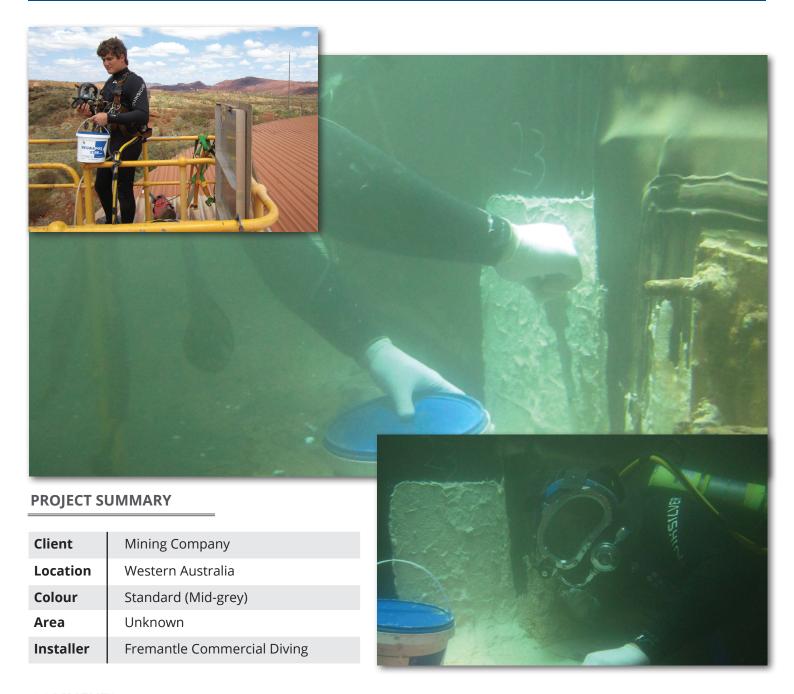
- A large mining company in Western Australia had multiple leaks in one of their main water tanks. The massive 60m diameter x 15m high tank had previously been lined with High Density Polyethylene (HDPE), but the seams were now splitting apart and had the potential to undermine the tank, resulting in the earthen base subsiding.
- Fremantle Commercial Diving used 150 litres of Scubapoxy 1725 underwater to seal all the leaking seams and apply a reinforcement material to prevent them from splitting in the future. The project was completed on time with the tank fully repaired and 100% dry.
- Fremantle Commercial Diving has developed an array of uses for Scubapoxy underwater epoxy products and have applied them in many projects with outstanding success.
